CATHODIC PROTECTION STUDIES

U. S. NAVAL CIVIL ENGINEERING LABORATORY  
Port Hueneme, California

Y-R007-08-901

Type B      Final Report

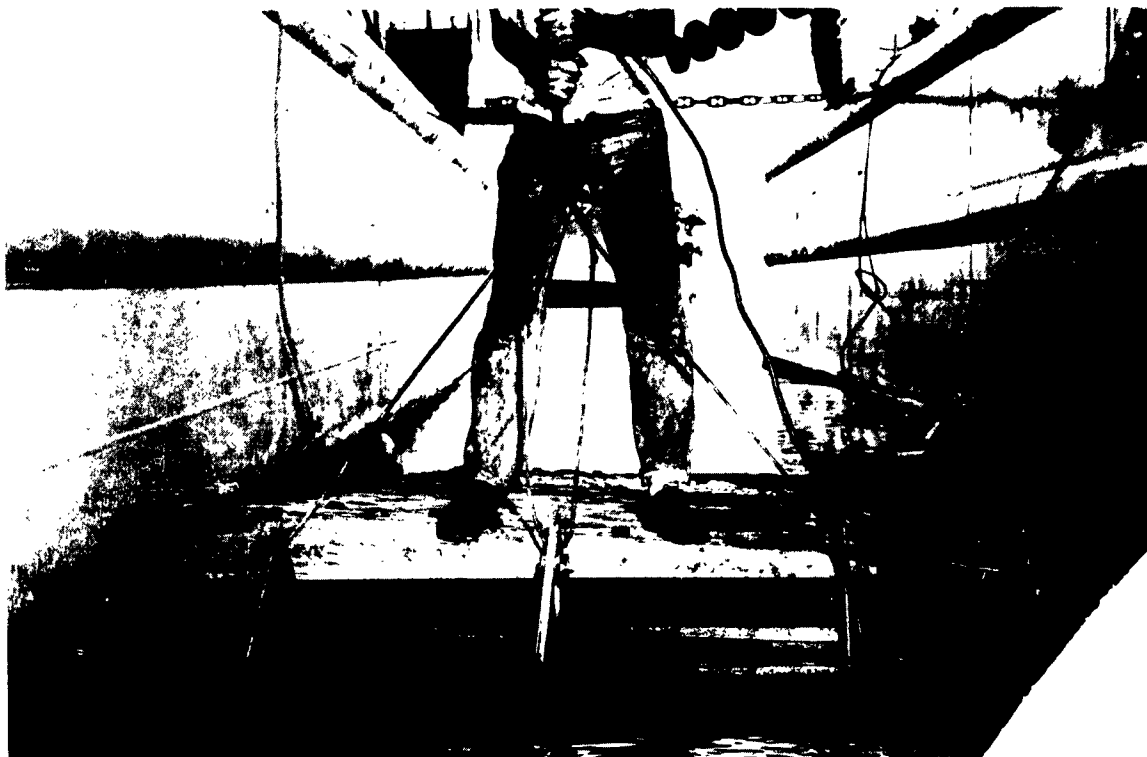
Figure 11. Bakelite support for 4-inch by 80-inch graphite anode.

Use of suspended anodes can result in appreciable strain on the anode cable. Small anodes may be suspended without difficulty, but when it is advisable to use larger anodes (as 4-inch-diameter by 80-inch-long), strain on the lead wire must be minimized. A method for accomplishing this is detailed in BuDocks Instruction 11012.55.<sup>5</sup>
